CONFINED MASONRY CONSTRUCTION

Mario Rodriguez, Universidad Nacional Autonoma de Mexico, Mexico

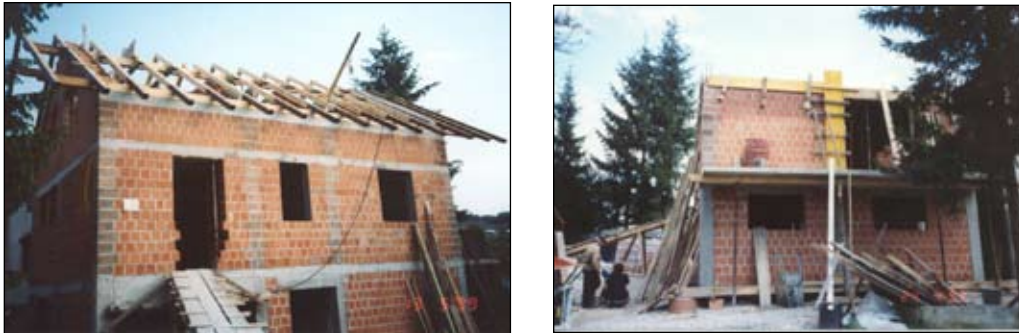
Figure 3: Confined masonry housing during construction in Slovenia (WHE Report 88)

A very important feature of confined masonry is that tie-columns are cast-in-place after the masonry wall construction has been completed. Alternatively, tie-columns are constructed using hollow masonry blocks to allow for placement of vertical reinforcement and cement-based grout. Figure 3 shows an example of the use of both types of tie-columns in residential construction in Slovenia. It can be observed that cast-in-place RC tie-columns are constructed at the first level, whereas hollow-block tie-columns are constructed at the second level. The minimum vertical reinforcement in tie-columns ranges from 4- to 10-mm-diameter bars in Chile and Mexico, to 4- to 14-mm-diameter bars in Slovenia. Both tie-columns and tie-beams have ties that provide confinement to the longitudinal reinforcement and help prevent the buckling of reinforcement. Typically, tie-columns consist of a rectangular section, with cross-sectional dimensions corresponding to the wall thickness, usually within the range of 150 to 200 mm. However, in Slovenia and Serbia, the minimum wall thickness is specified as 190 mm. Figure 4 shows an example of the masonry units used in Slovenia. The spacing of tie-columns is limited to 3 m in Mexico. In Chile, RC structural walls of a minimum 1 m in length are required in buildings in which a plan dimension exceeds 20 m. These walls need to be placed at the building perimeter.

The floor system in confined masonry construction typically consists of composite masonry and concrete joists as shown in Figure 4 or cast-in-place concrete slabs. In some cases, timber roofs are used in combination with tie-beams as shown in Figure 3.

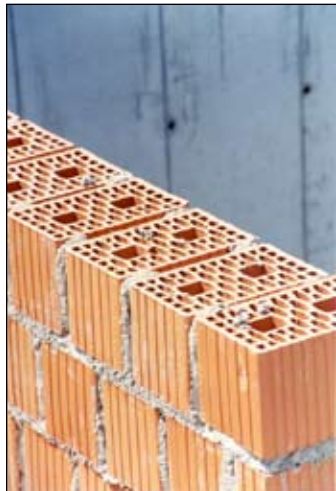
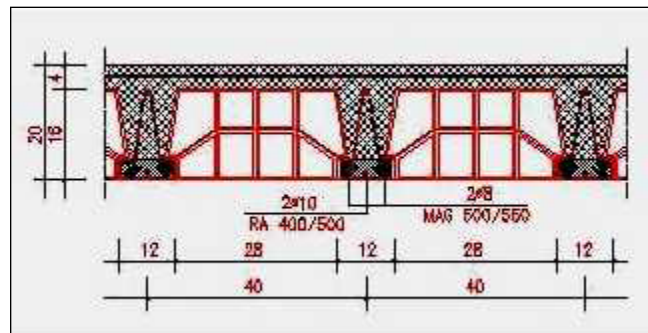
Figure 4: Masonry units used in confined masonry construction (left, Slovenia, WHE Report 88) and a detail of floor construction (right, Serbia and Montenegro, WHE Report 69)

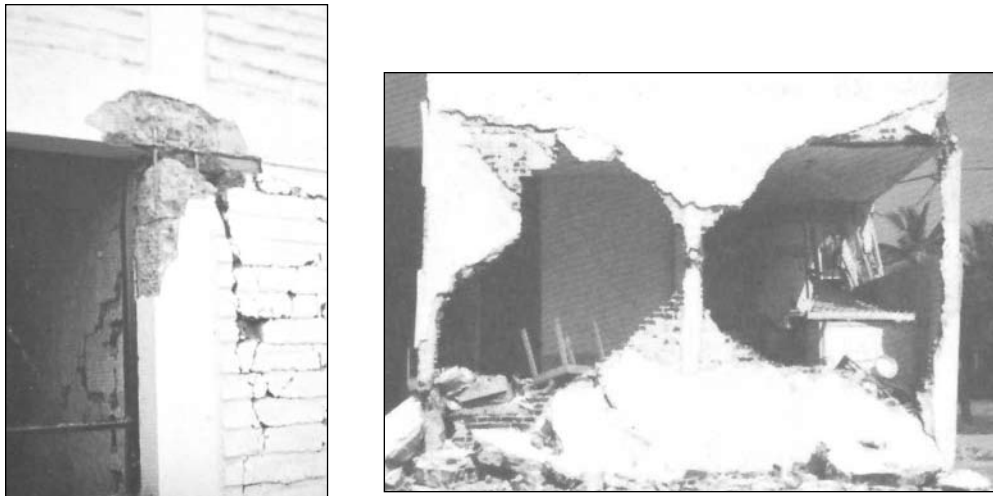
Figure 5: Damage to confined masonry construction in the 1985 Lolleo, Chile, earthquake (Chile, WHE Report 7)

If properly constructed, confined masonry construction is expected to show satisfactory performance in earthquakes. The adverse behavior observed in past earthquakes involved houses that were built without tie-columns and/or tie-beams, with inadequate roof-to-wall connection, or with poor-quality materials and construction. Major earthquakes that have affected confined masonry construction include the 1985 Llole, Chile, earthquake (M 7.8) and the 1990 Manjil, Iran, earthquake (M 7.6). Confined masonry buildings suffered light damage in the 1985 Llole earthquake and collapse was not reported. In most of the damaged buildings, tie-columns were missing and the following characteristic damage patterns were observed (see Figure 5):

- Shear cracks in walls that propagate into the tie-columns; most cracks passed through mortar joints. Also, crushing of masonry units has been observed in the middle portion of the walls subjected to maximum stresses.

- Horizontal cracks at the joints between masonry walls and reinforced concrete floors or foundations.
- Cracks in window piers and walls due to out-of-plane action in inadequately confined walls.
- Crushing of concrete at the joints between vertical tie-columns and horizontal tie-beams when the reinforcement was not properly anchored.

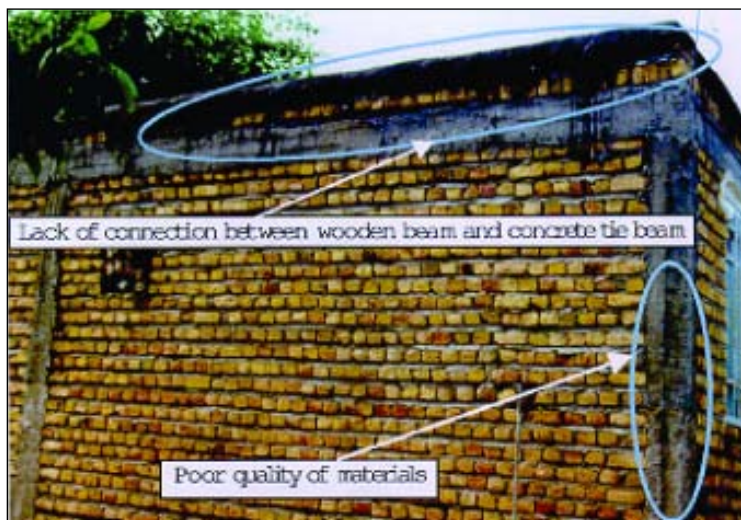
Figure 6: Seismic deficiencies found in confined masonry construction (Iran, WHE Report 27)

Damage patterns in the 1990 Manjil, Iran, earthquake are similar to the ones reported above (Iran, WHE Report 27), as shown in Figure 6. It seems that the earthquakes of magnitude 6, or smaller, have not caused major damage to confined masonry construction.
